**Other OEM Manufacturers and specifications:**

**Problem:** Small cracks may form on certain fuel tanks on TecumsehPower engines identified above in the area where the tanks have been welded. If this occurs the tanks may seep gasoline and create a fire hazard.

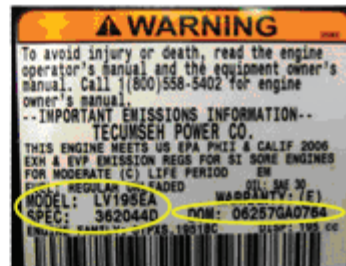
**Figure 2**

**Date Codes:** The engine model number and date of manufacture information is located on the side of the engine housing. See Figure 1. The tanks in question are on engines that have dates of manufacture (DOM) codes beginning with **07001G** and ending **07120G**. See Figure 2.

Engine ID decal with DOM

**What To Do:** Authorized dealers should check the DOM on any lawn mower engine, tiller, pressure washer or edger on above listed models that comes in for service. If the engine DOM falls within the range, the dealer should inspect the fuel tank for cracks near the area of the tank weld seam/joint. If cracks or leaks from the fuel tank are found, a replacement tank **1A116-452-95** can be obtained by using the following process:
