TECHNICAL SERVICE BULLETIN

TO: ALL AUTHORIZED LCT ENGINE / HUSQVARNA SERVICING DEALERS
SUBJECT: POTENTIAL ISSUE RELATING TO PTO COVER ANOMOLIES – 414cc SNOW ENGINE
DATE: FEBRUARY 20, 2013

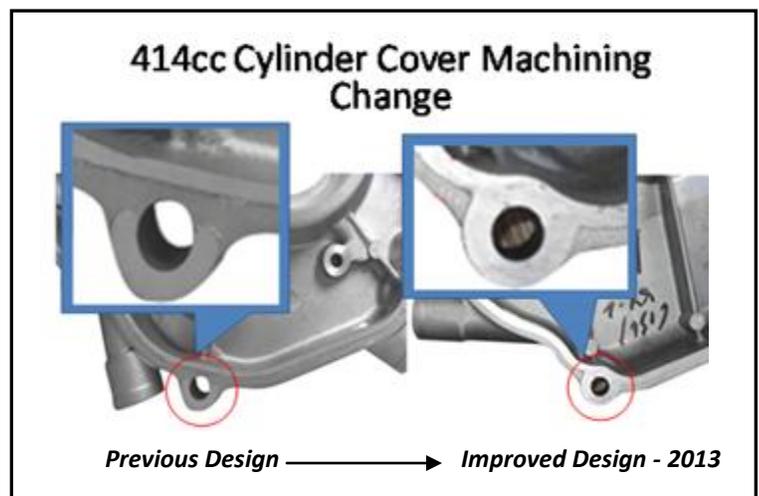
Figure 1 (design improvement for engines produced after 2012)

A small percentage of Husqvarna 414cc two-stage snow throwers, powered by the LCT 414cc Snow King series of engines produced in 2011 and 2012, sold in North American and European markets, could have a leaking oil condition caused by PTO cover gasket surface abnormalities. This failure mode, defined as PTO cover bolt torque reduction due to gasket surface abrasion, has been addressed through a complete engineering design change (see photos: Figure 1), implemented for the 2013 snow engine production season.

In the unlikely event this failure mode is encountered, there is a service kit designed specifically for this repair which includes a PTO cover with a continuously machined gasket surface, and a new PTO cover gasket.

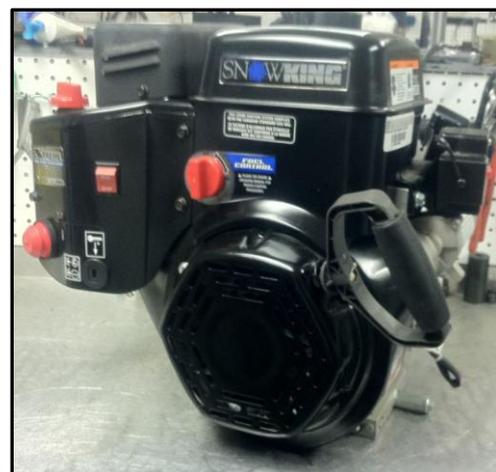
Snow King 414cc two stage snow blower engine.

Drain the remaining oil in the engine, then use the recoil to slowly rotate the engine to TDC (top dead center), on the compression stroke. Rotating the engine to TDC on the compression stroke, prior to removing the PTO cover, will relieve lifter pressure on the camshaft and allow proper removal of the used PTO cover, and installation of the new PTO cover.

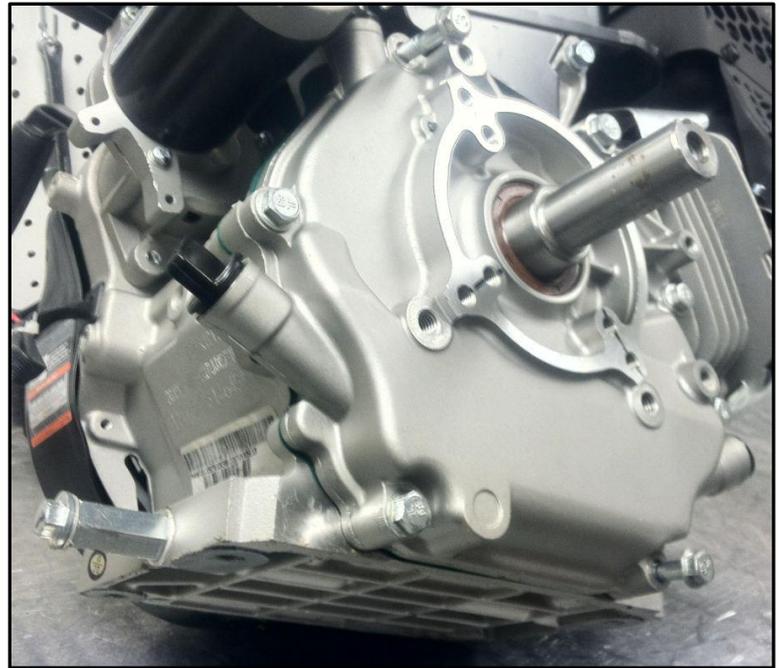
Proper removal of PTO cover bolts; 414cc Snow King

Tilt the engine toward the recoil cover, and remove the PTO cover bolts.

Tilting the engine toward the recoil cover will reduce the possibility of residual oil spilling from the crankcase during removal of the PTO cover, while also providing a good working area to access the PTO cover, PTO cover bolts, and PTO cover gasket.
